UNIVERSITY OF VIRGINIA

PAVILION IX

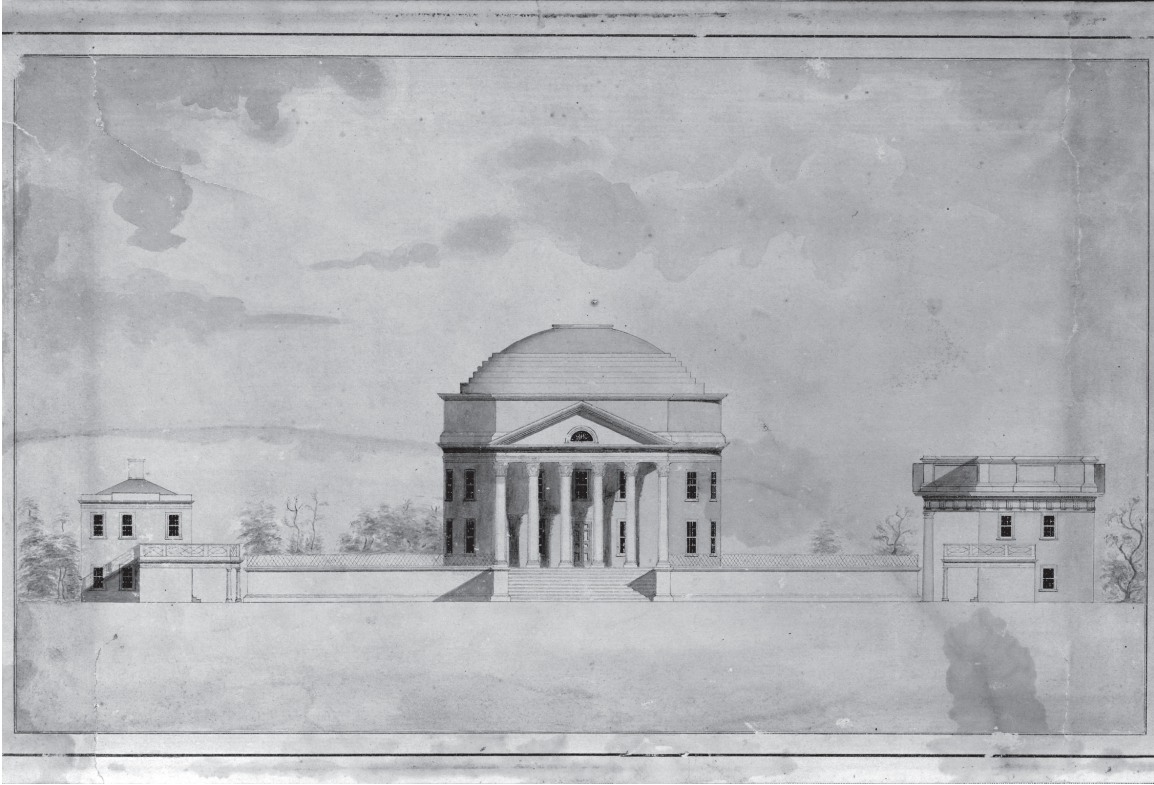
*Study of the Rotunda and Pavilions IX (to the left) and X (to the right), February 1823
This sketch has been variously attributed to Cornelia Jefferson Randolph,
John Neilson, and Benjamin Henry Latrobe; Neilson is now recognized as the artist*

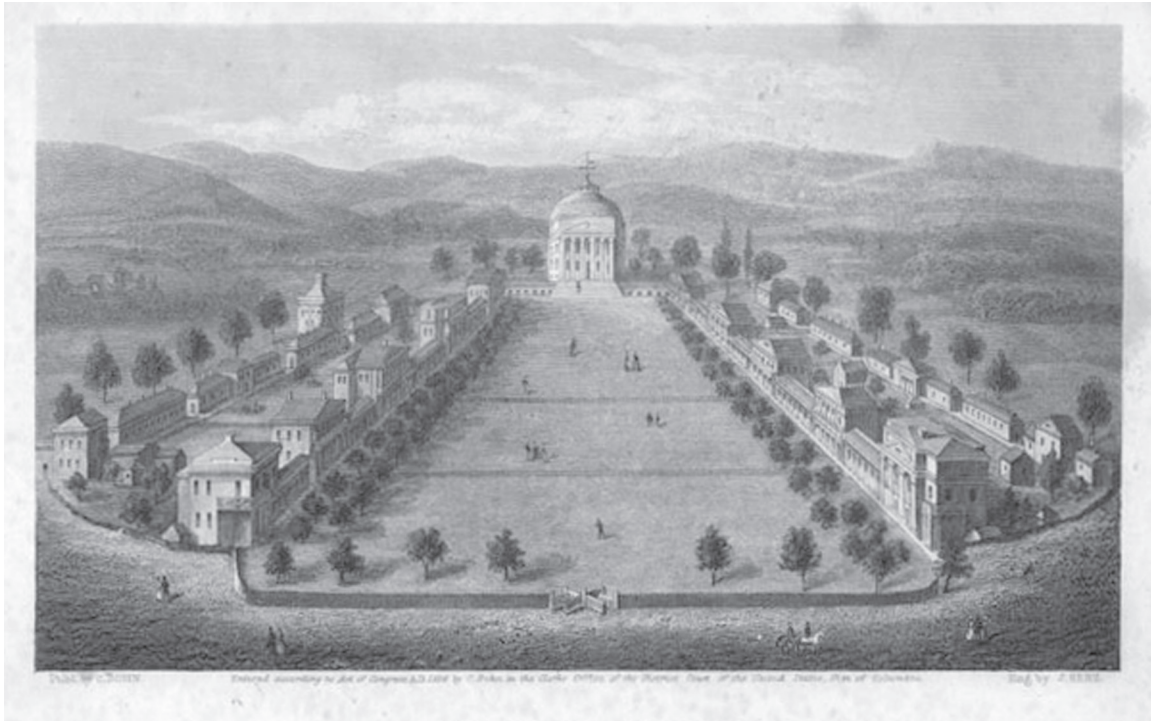
*Engraving of University of Virginia by J. Serz,
published by C. Bohn, 1856*

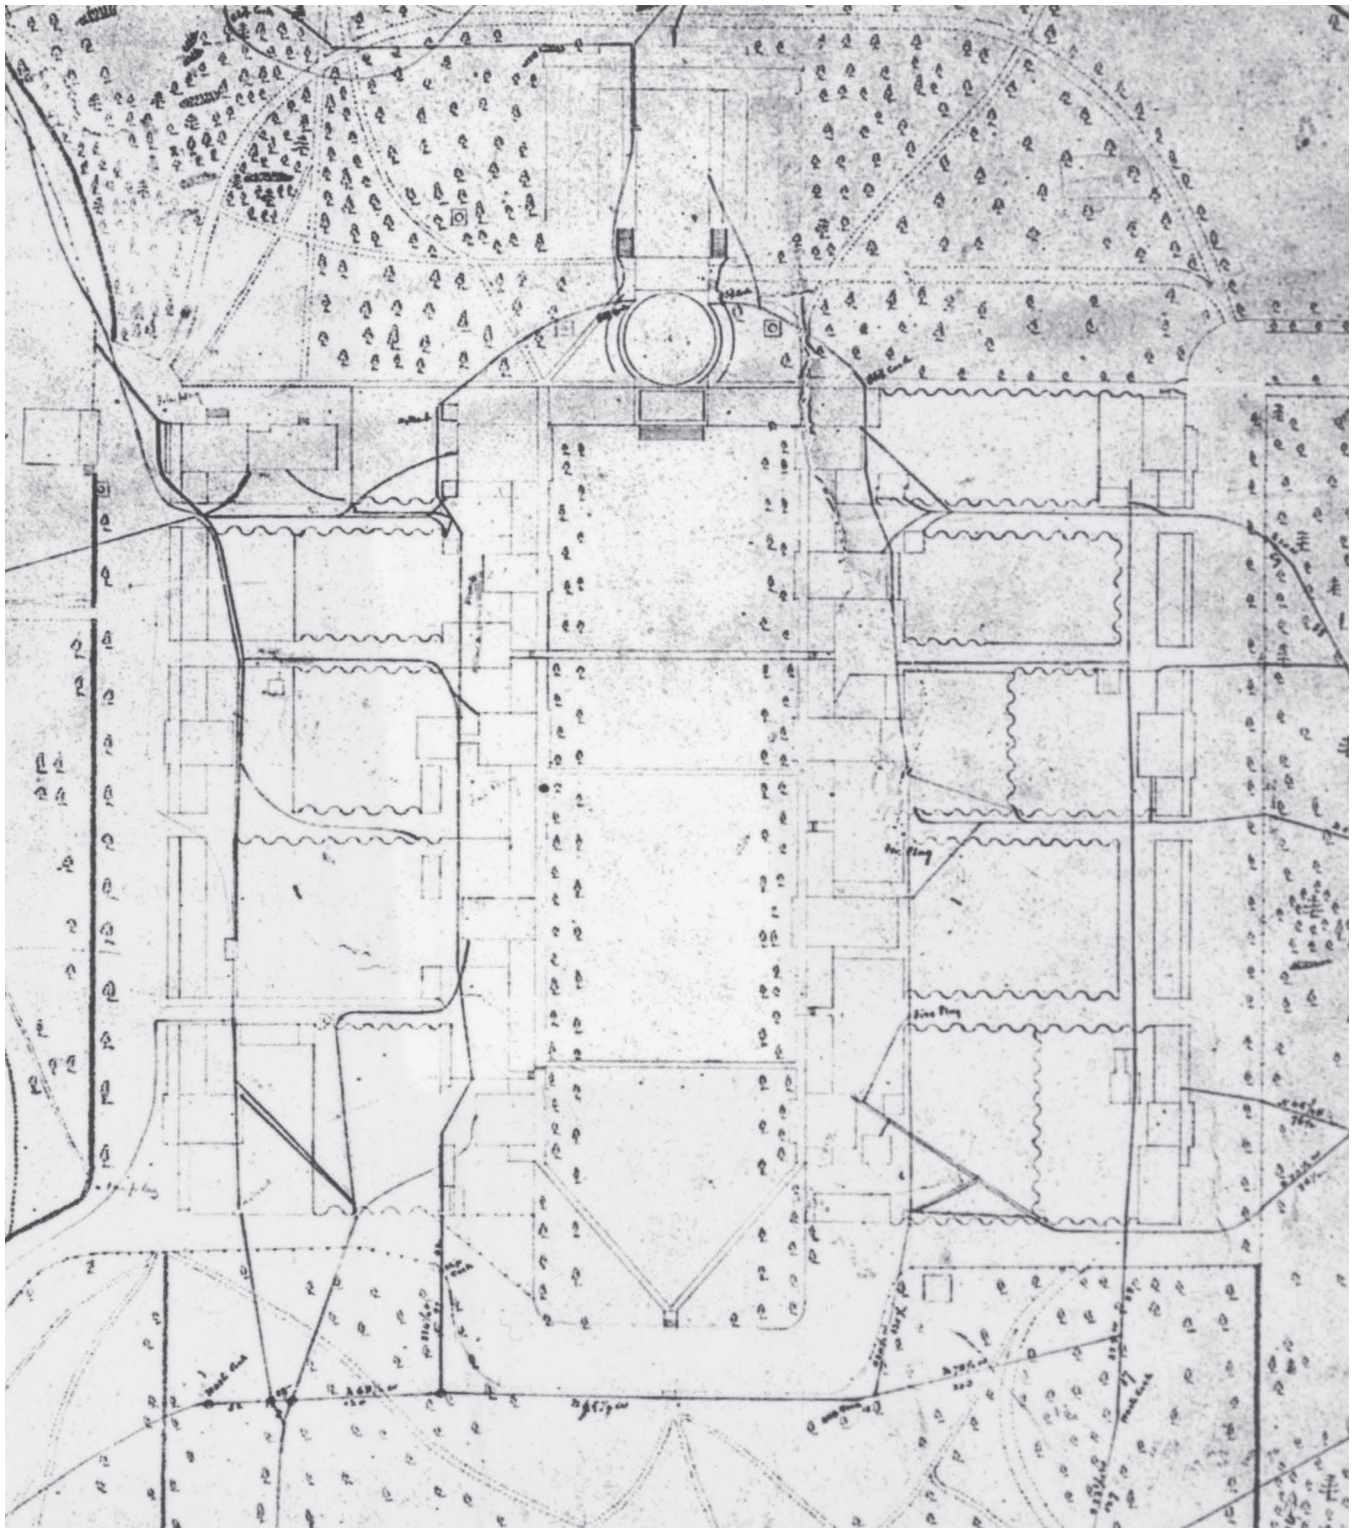
1870s utilities map of the Lawn

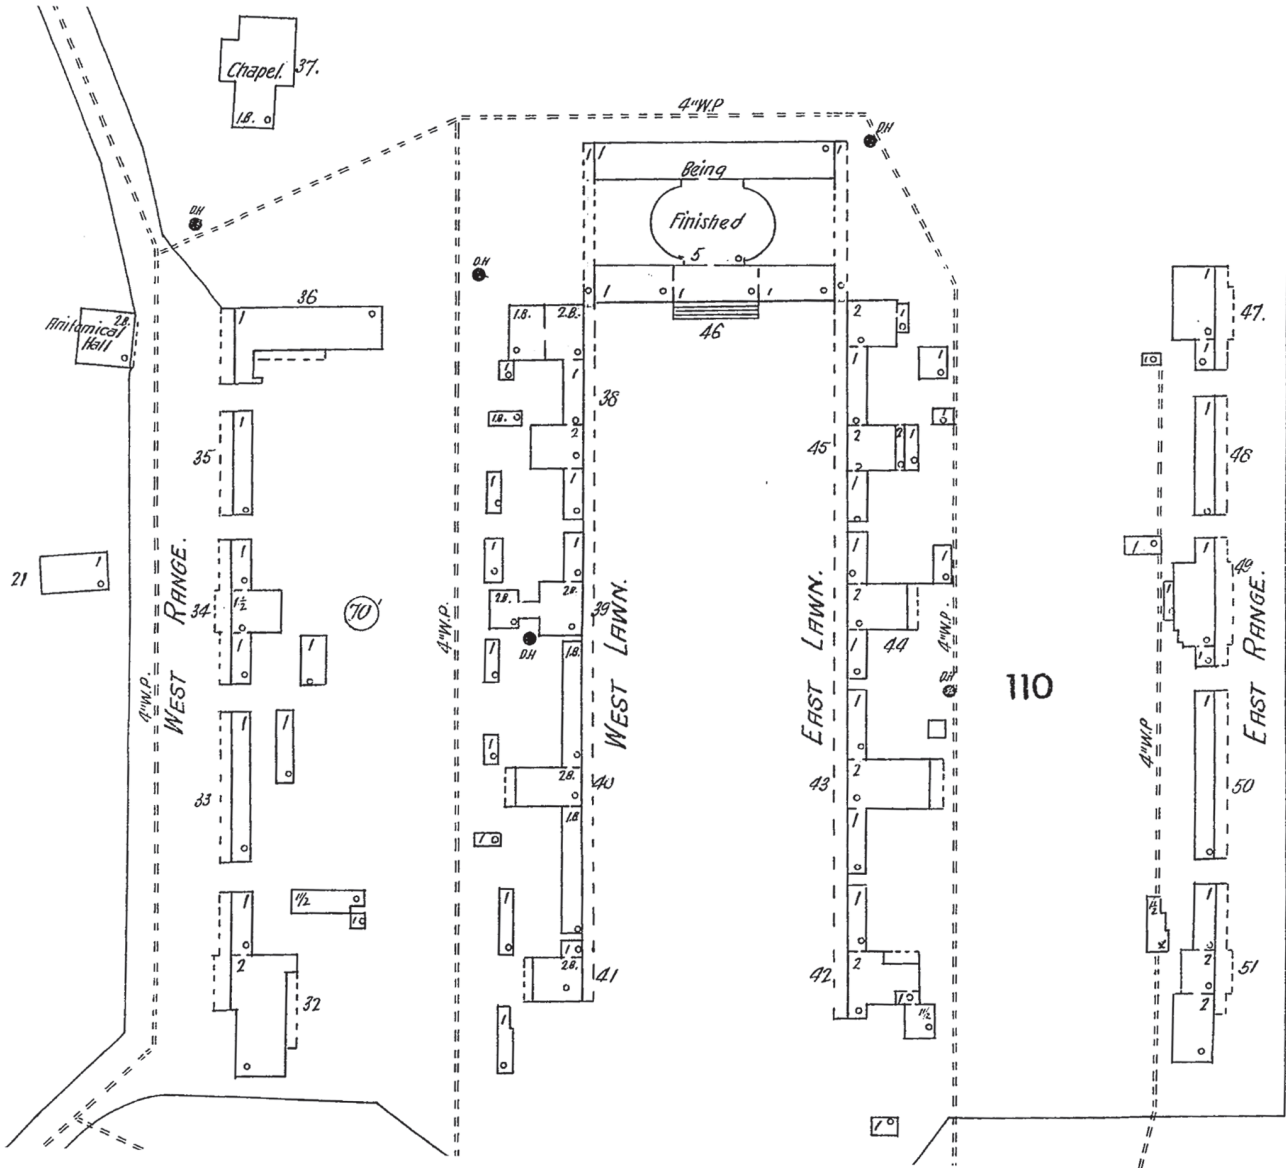
Sanborn map of the Lawn, 1896

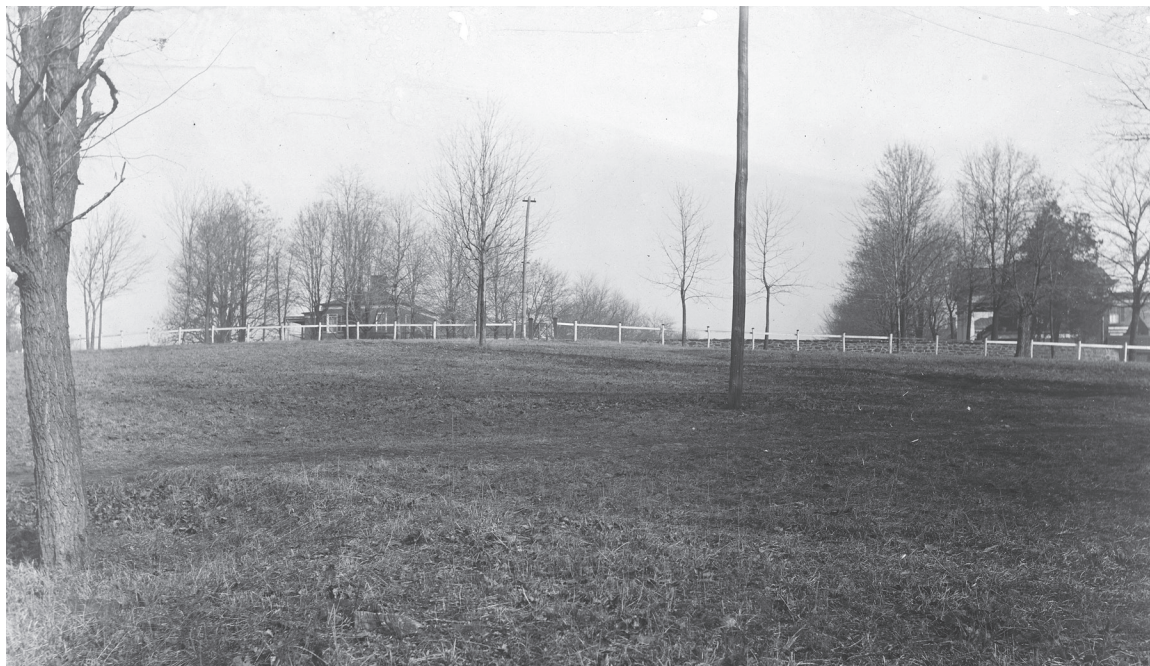
This view of the Lawn from the south, taken by McKim, Mead, and White in 1896, shows a glimpse of Pavilions IX and X

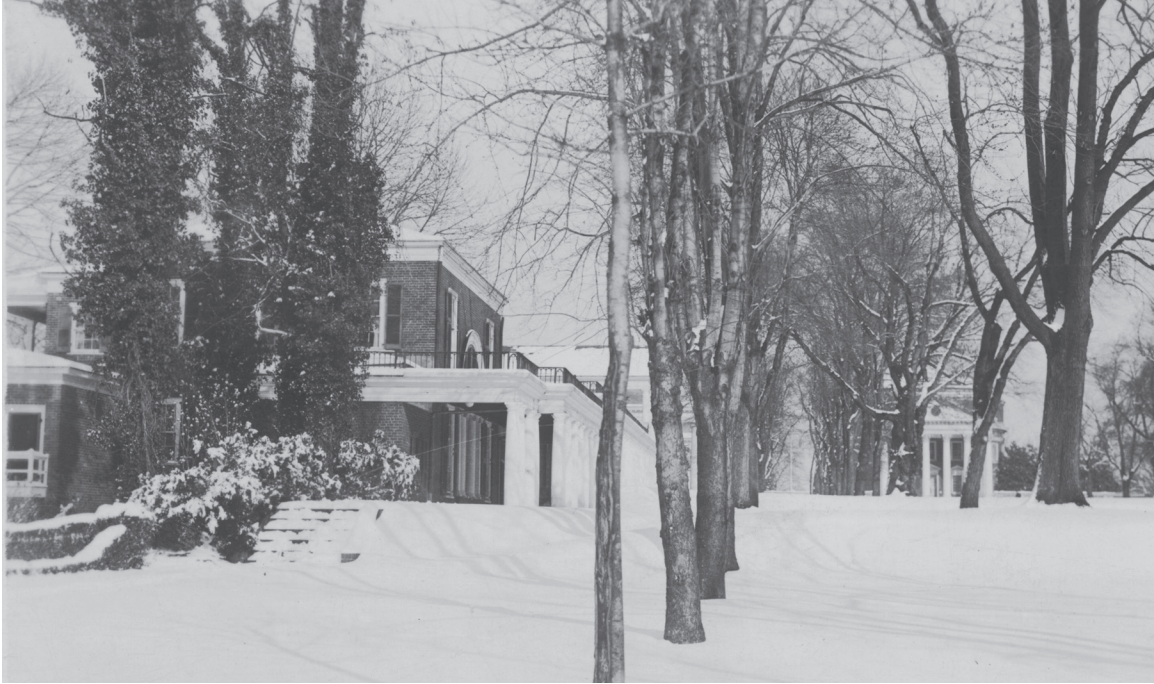
Pavilion IX from the south, 1900, showing the southwest addition

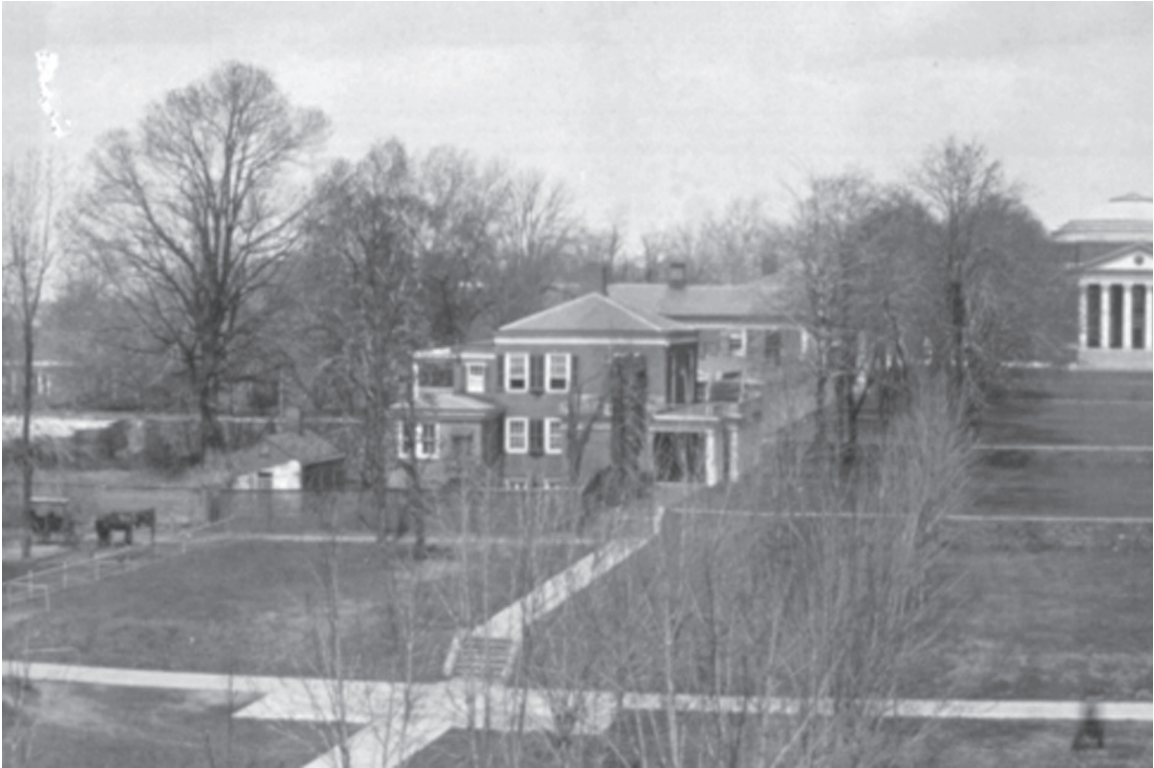
Detail from panoramic view of the Lawn by Rufus Holsinger, circa 1911

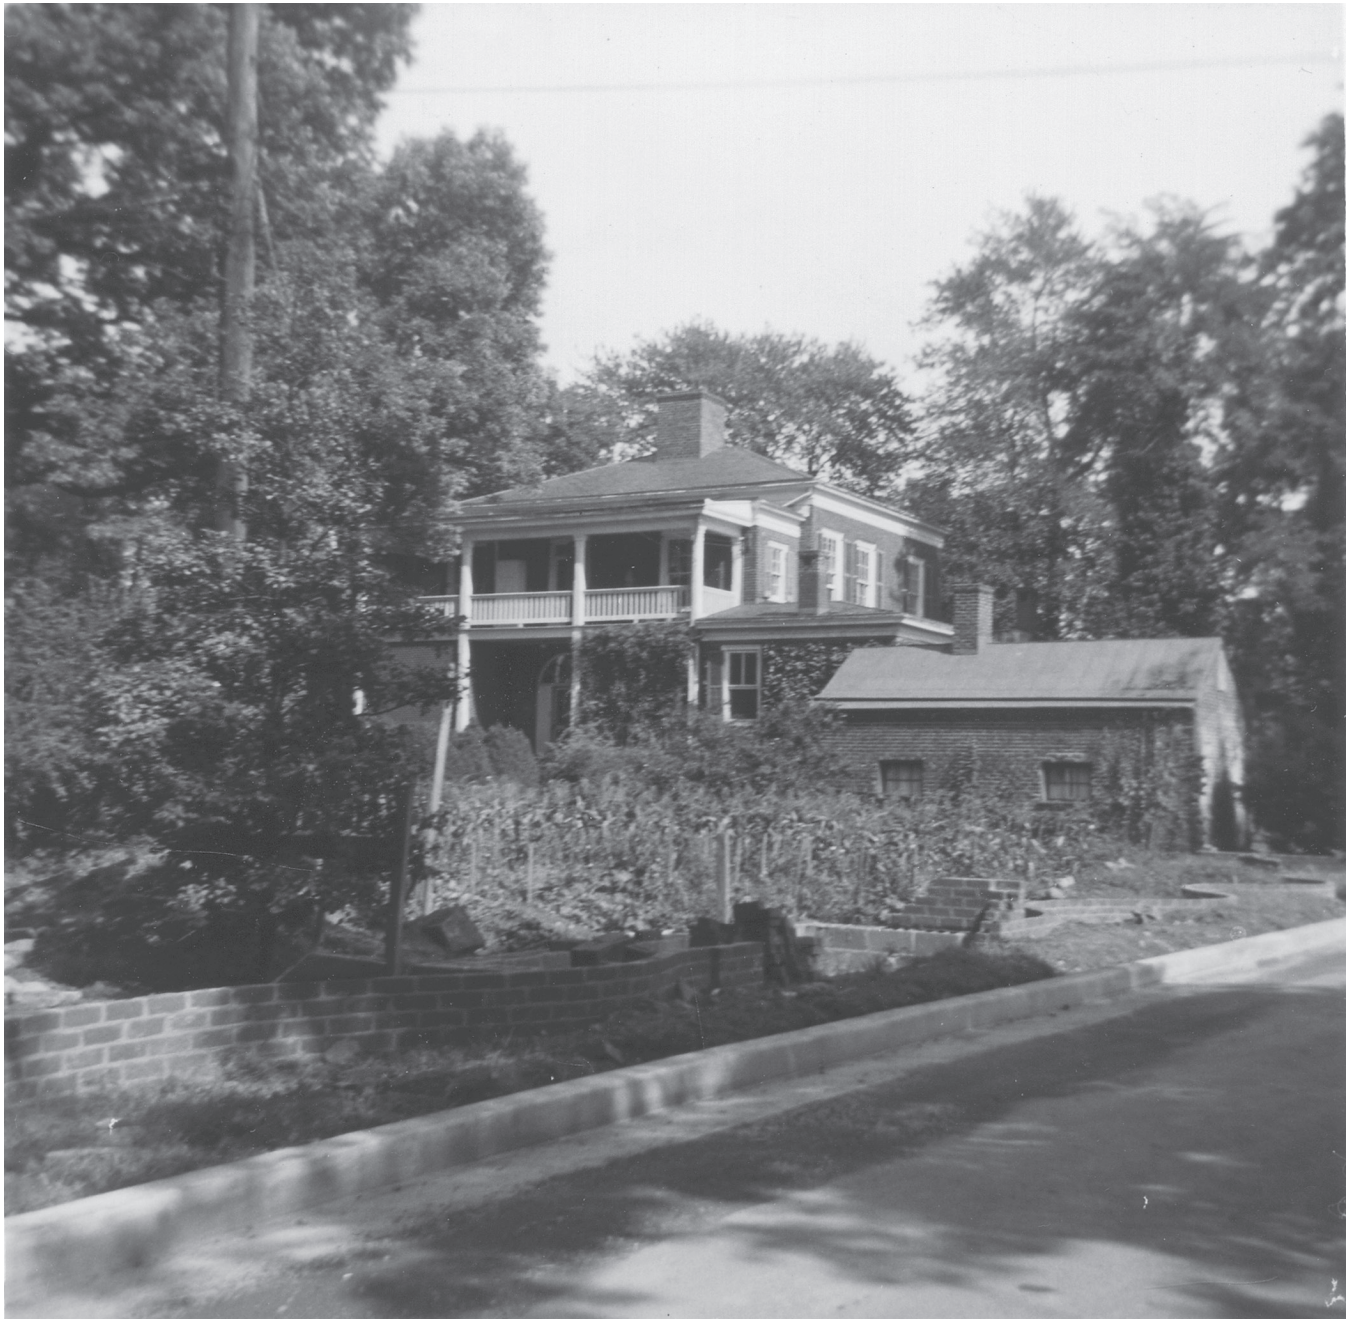
*A rare view of Pavilion IX from the west, taken in September 1951
when a new serpentine garden wall was constructed*

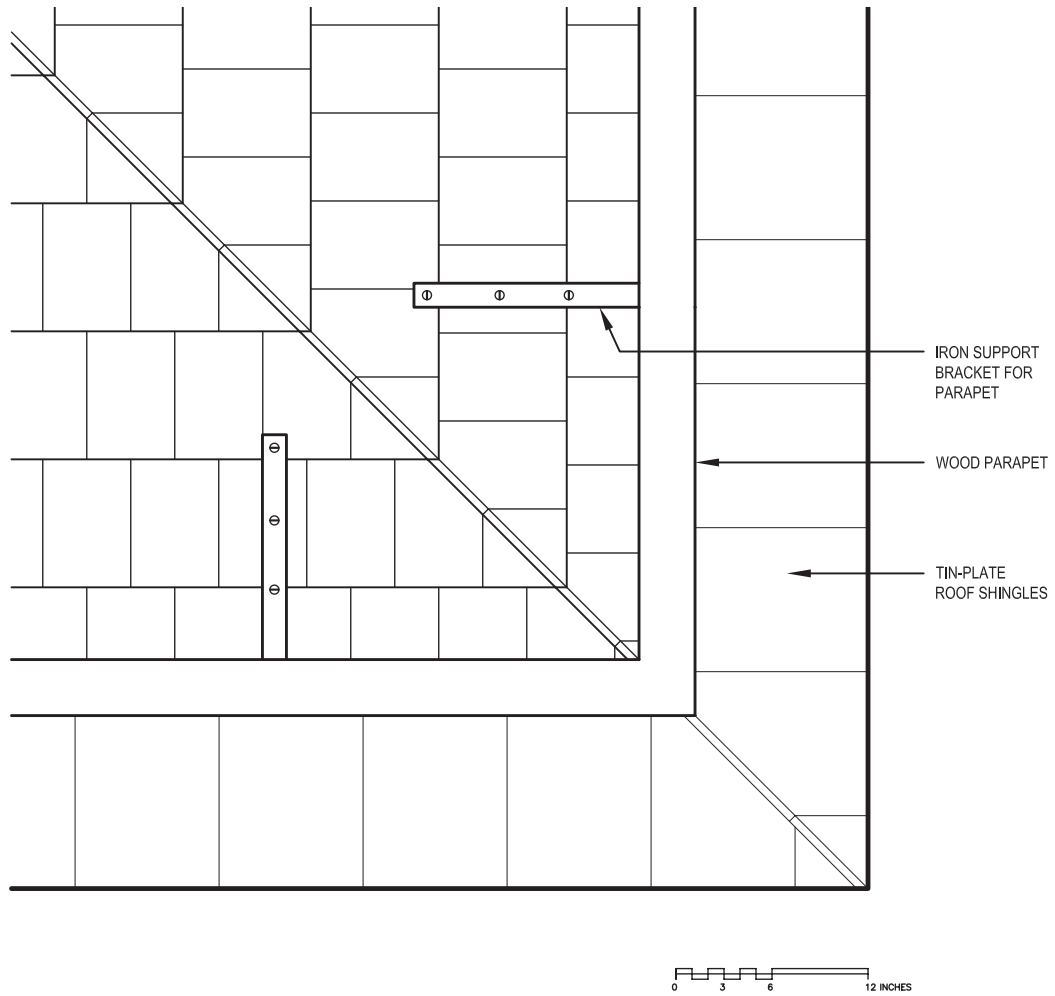
Corner of original roof surface, showing position of parapet

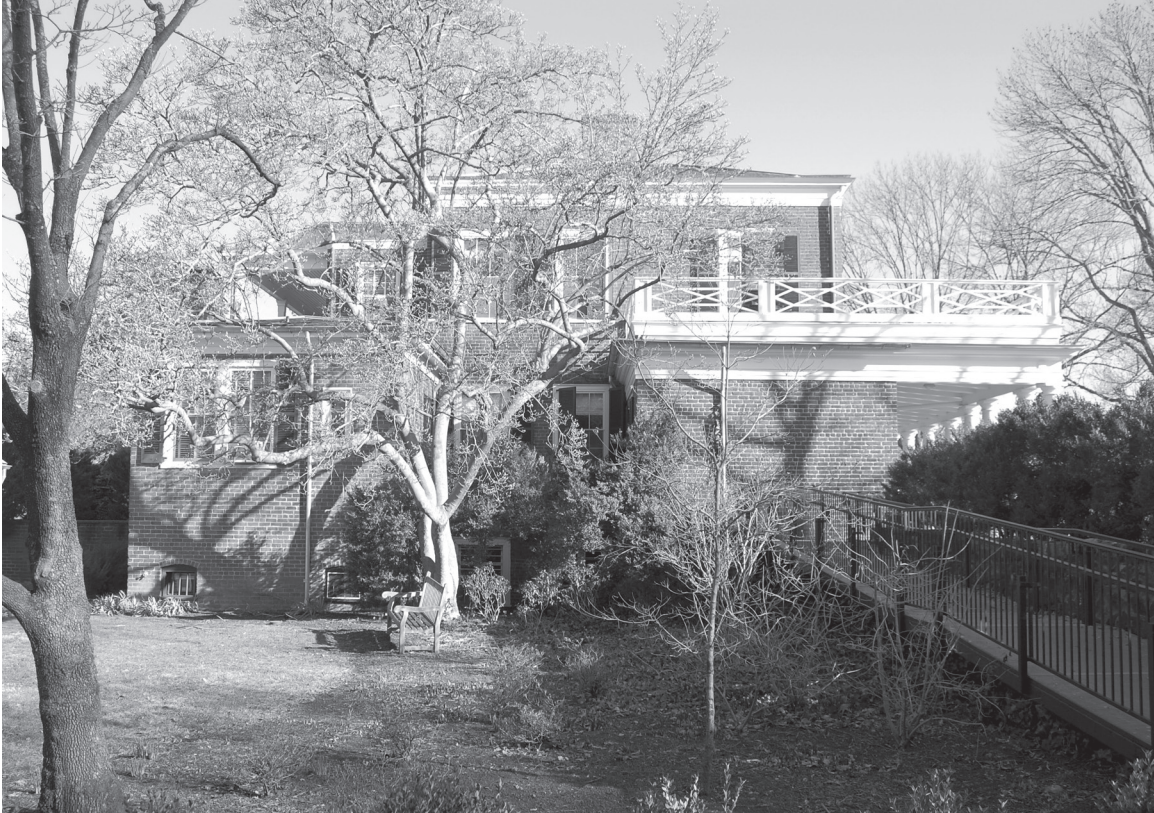
Pavilion IX from the south

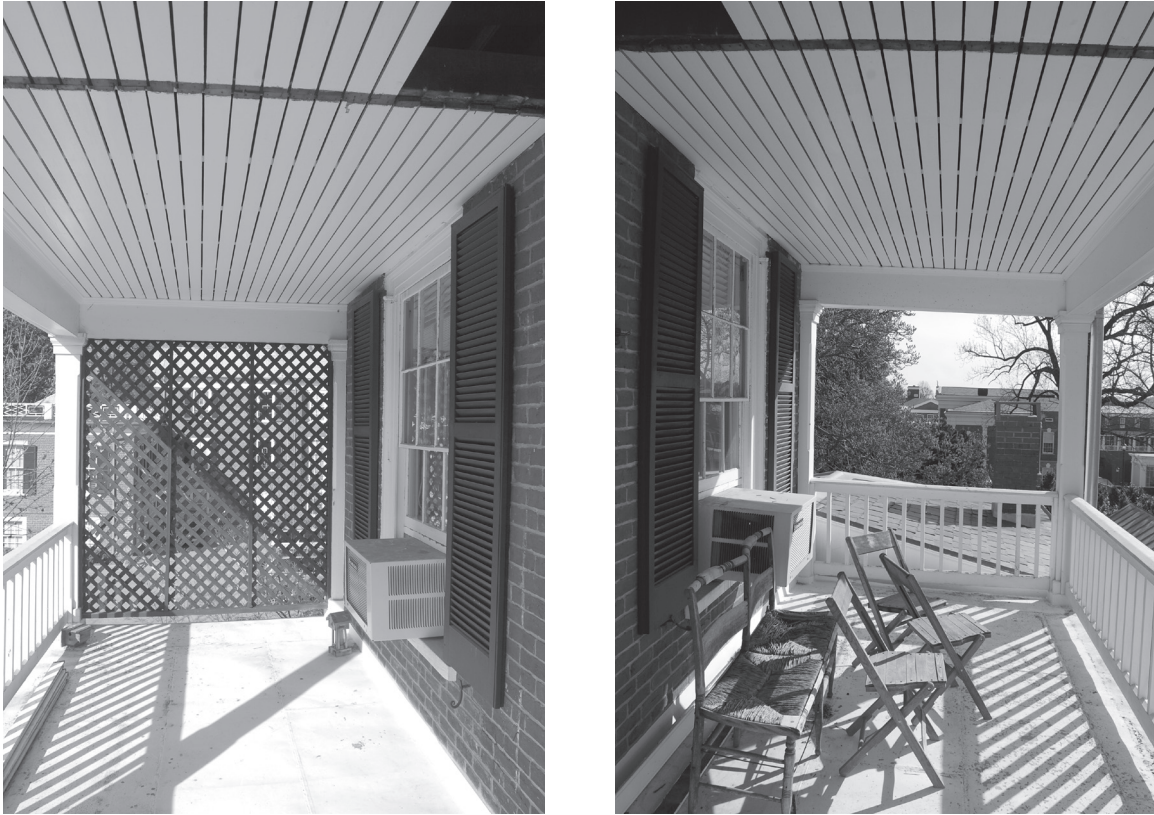
Second floor of the west porch of Pavilion IX, looking north (left) and south (right)

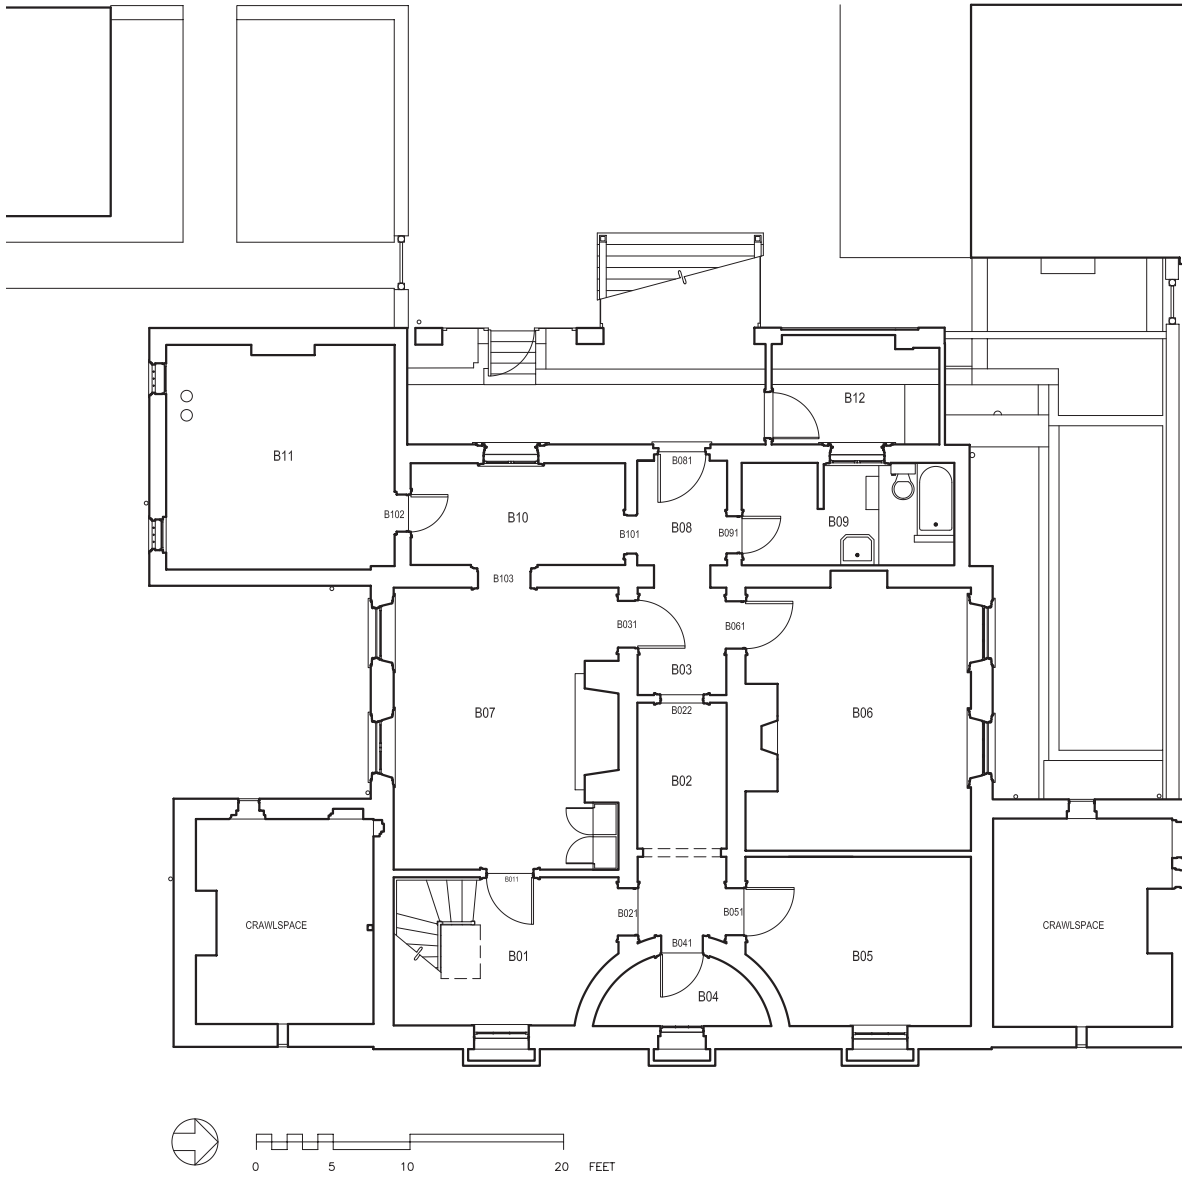
ARCHITECTURAL DESCRIPTION

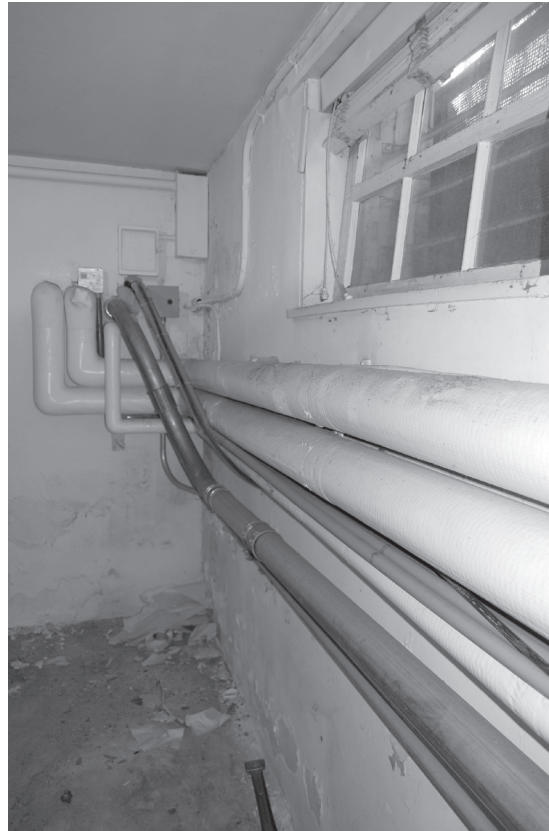
Room B05, looking north

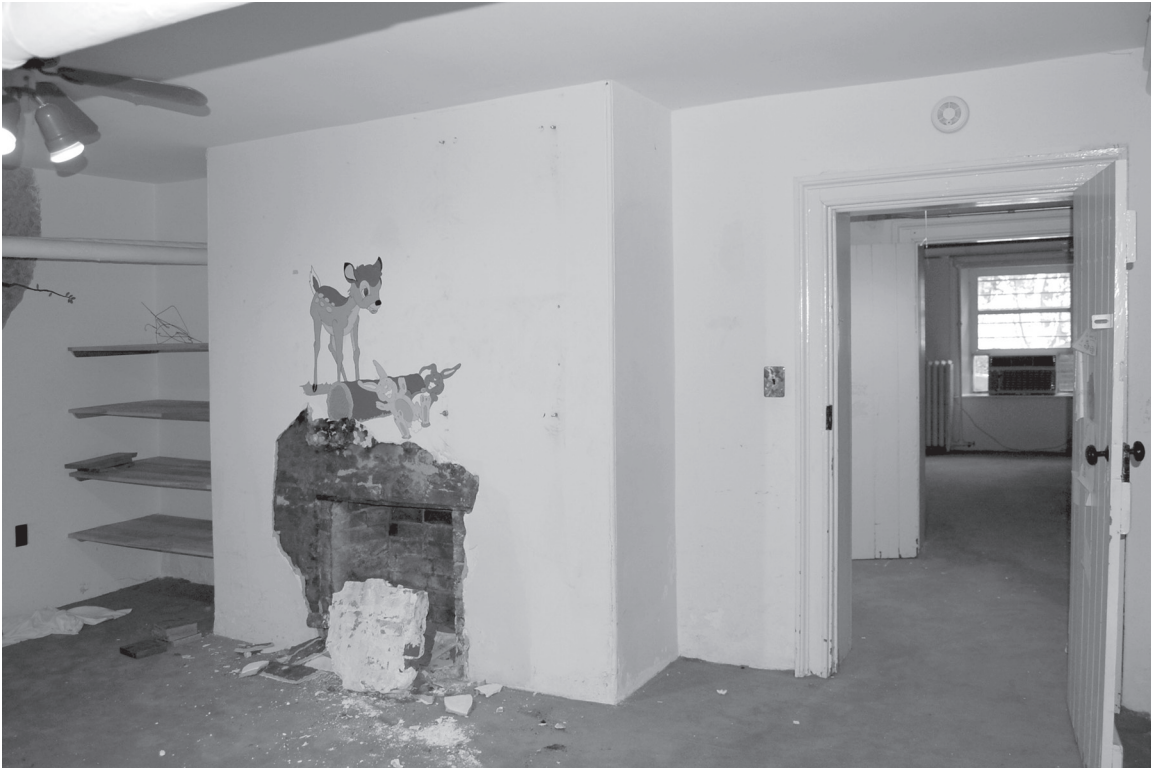
Room B06, looking southeast

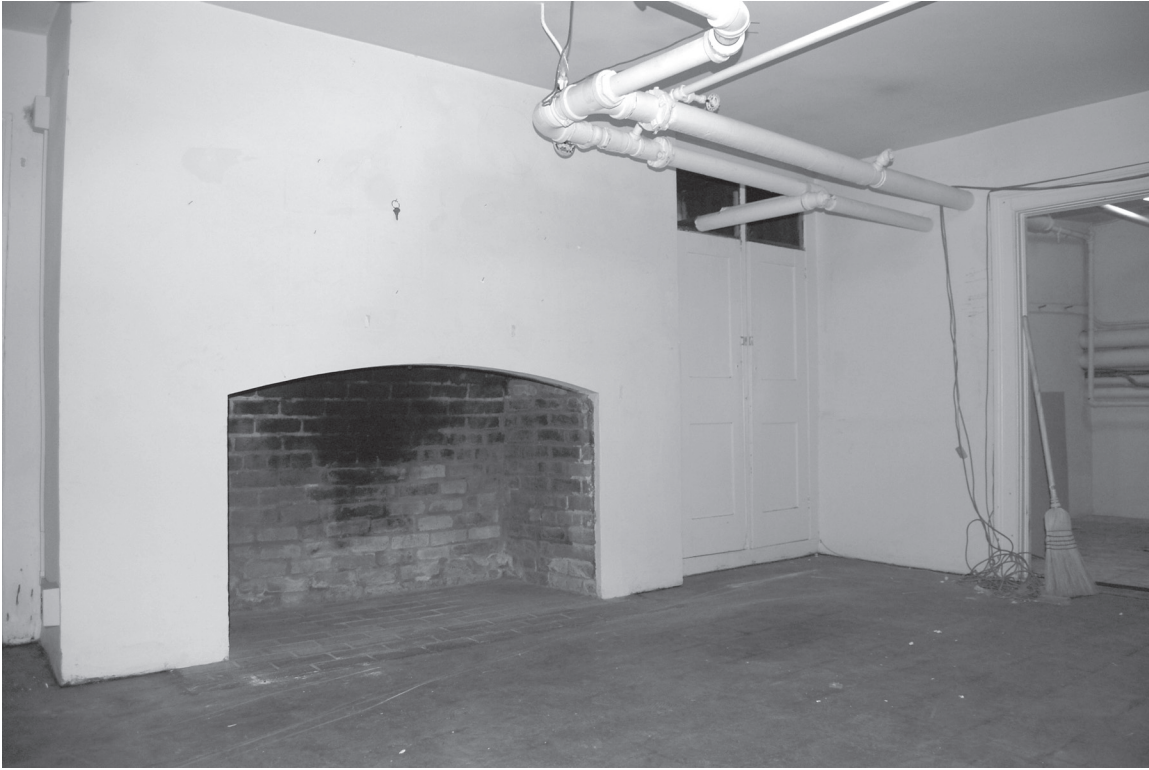
Room B07 (original kitchen), looking northeast

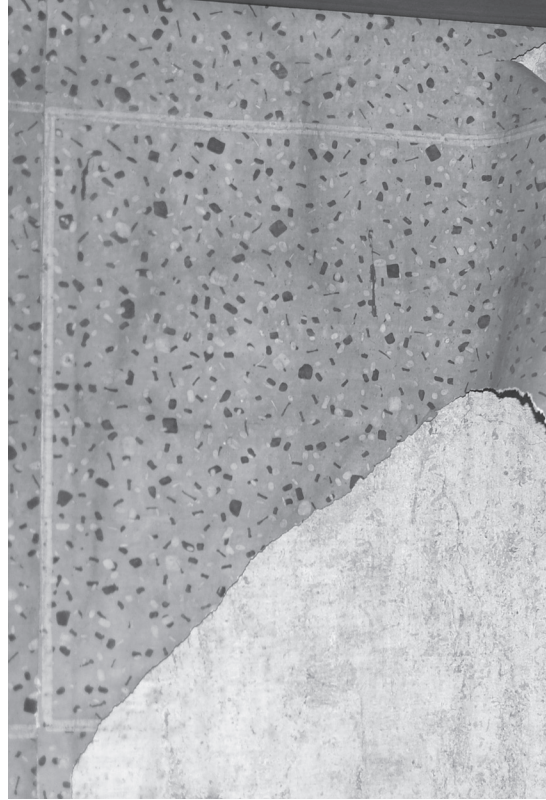
Wallpaper fragment found in B07 closet.

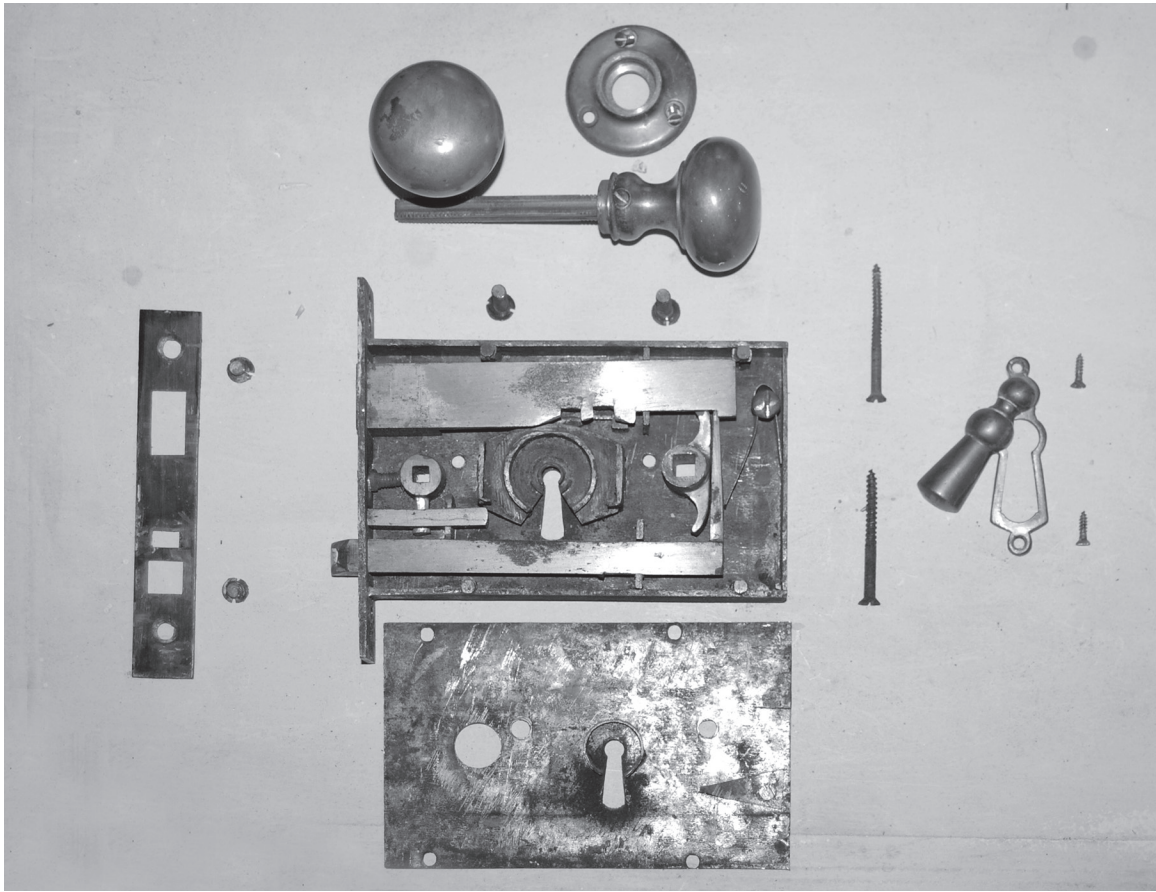
Dismantled original mortise lock from door no. 1041 (between rooms 101 and 104)

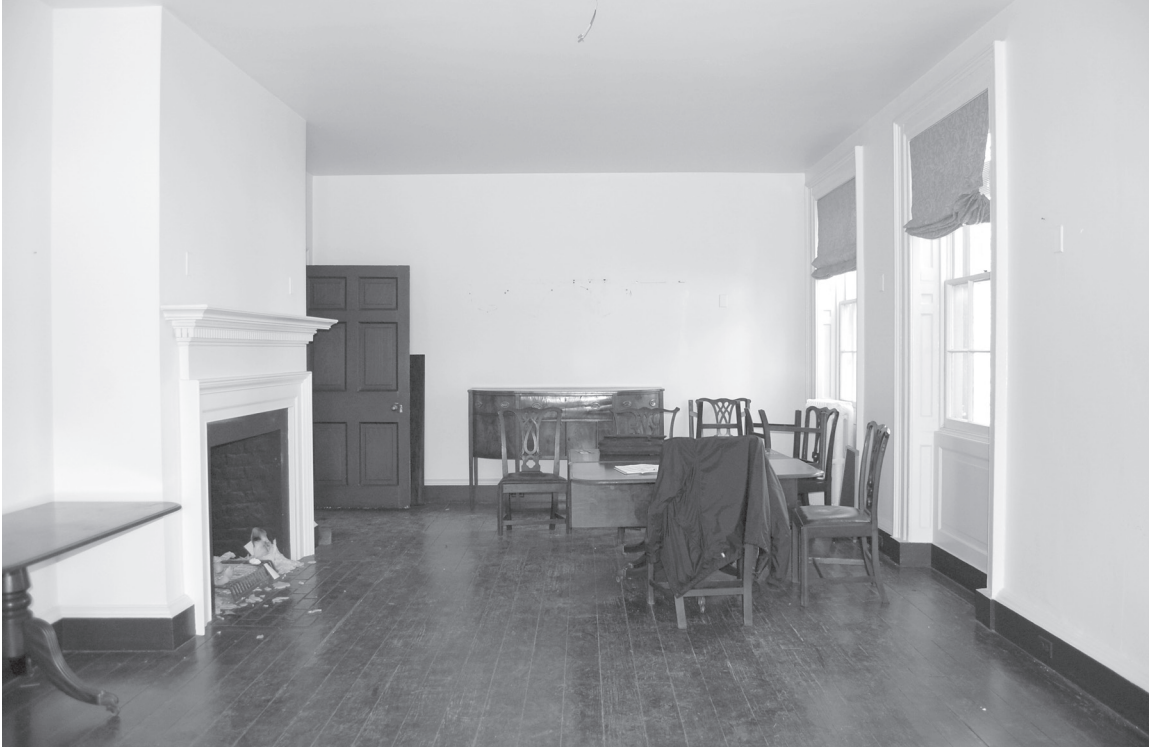
Room 102 (original lecture room), looking west

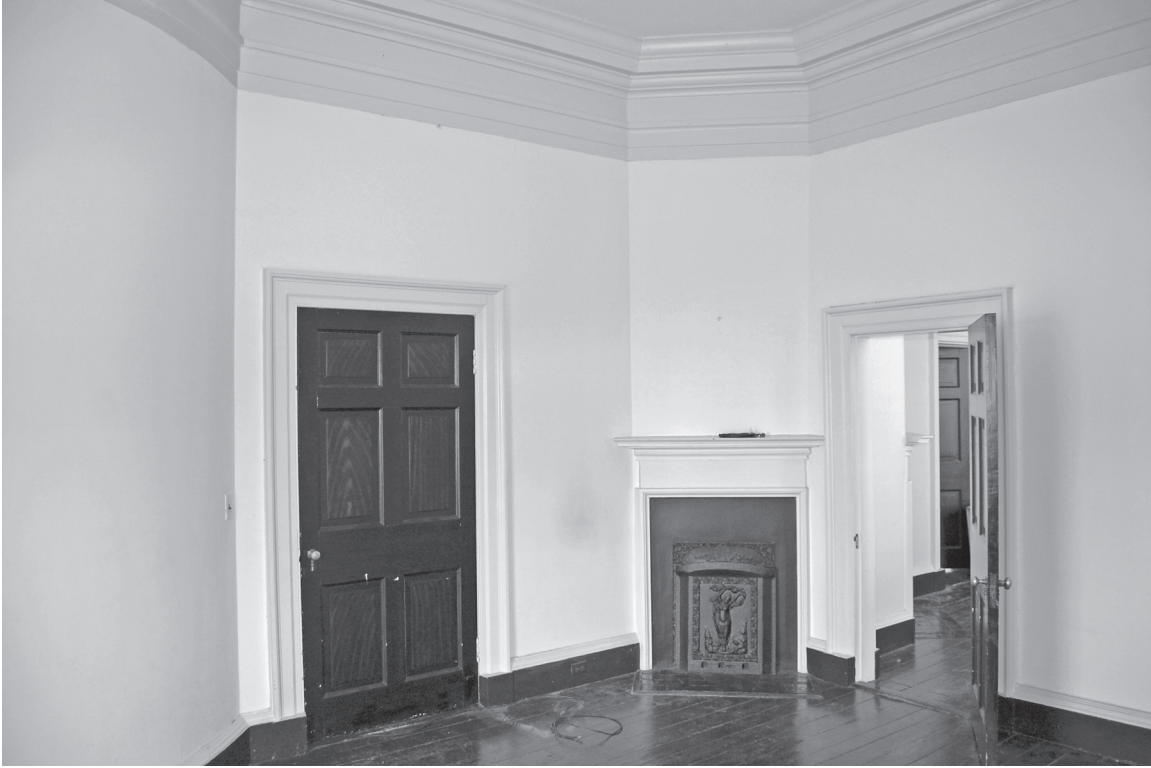
Room 203 (bedroom), looking southwest

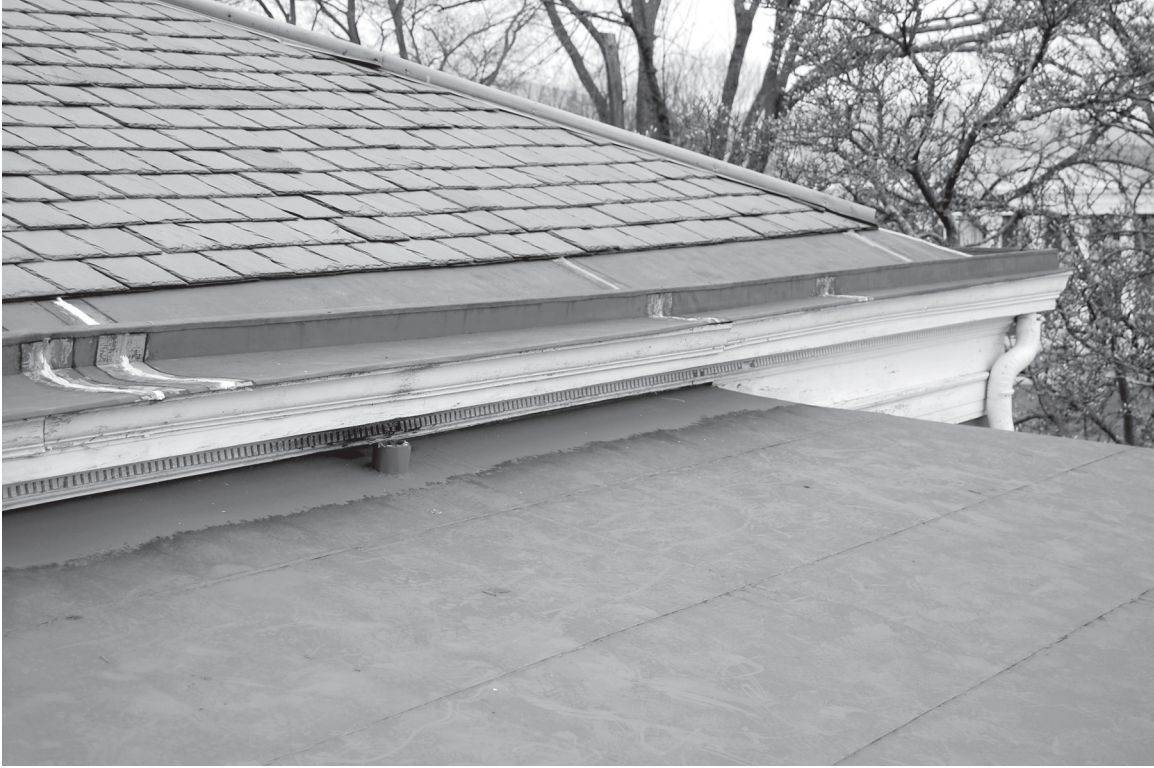
Roof eave at southwest corner of pavilion. Temporary repairs at seams in the sheet metal gutter have been removed, exposing unpainted terne-coated steel. The exposed metal is rusting and the seams have been caulked in an attempt to prevent water infiltration. The painted wood cornice above the plumbing vent is rotting. The flat-lock seams in the painted terne-coated steel roofing on the rear addition are rusting.

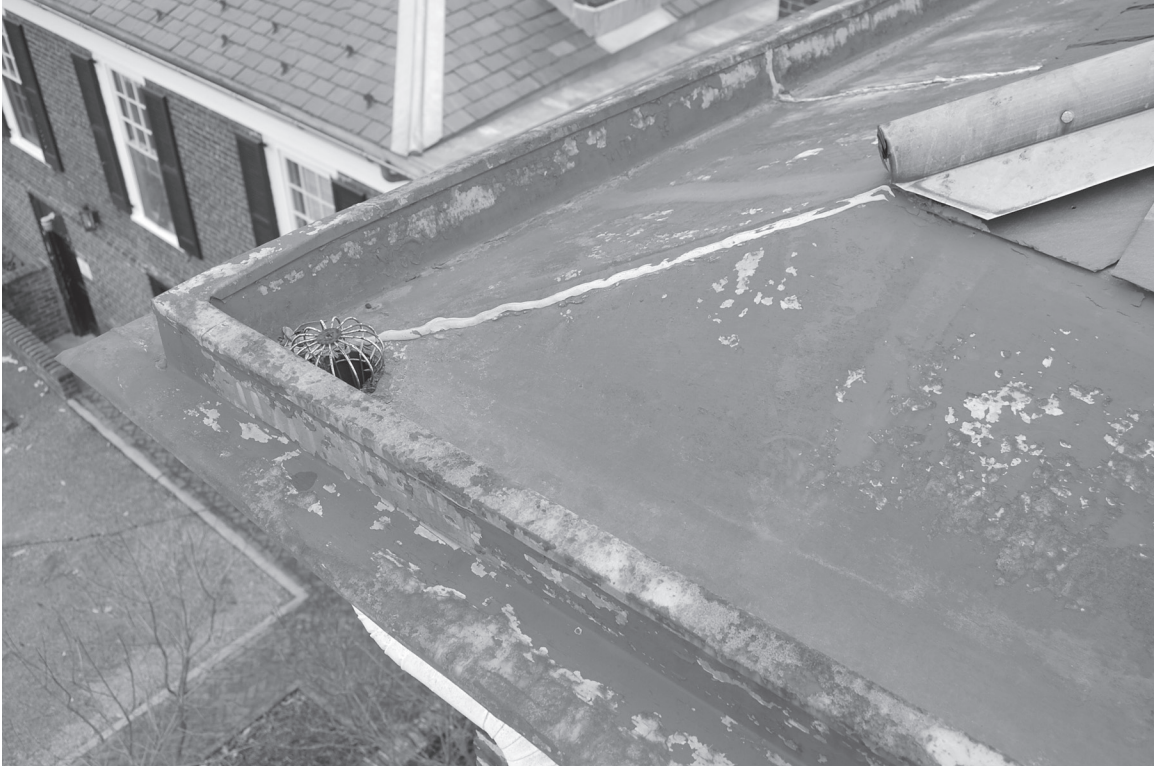
Roof eave at northwest corner of pavilion. The paint on the terne-coated steel gutter is peeling and the sheet metal is rusting. Caulk has been used to repair failed solder at the seams. The juxtaposition of dissimilar metals (copper ridge flashing and steel gutter) creates a galvanic couple in the presence of an electrolyte (rainwater) that accelerates the deterioration of the less noble metal (steel).

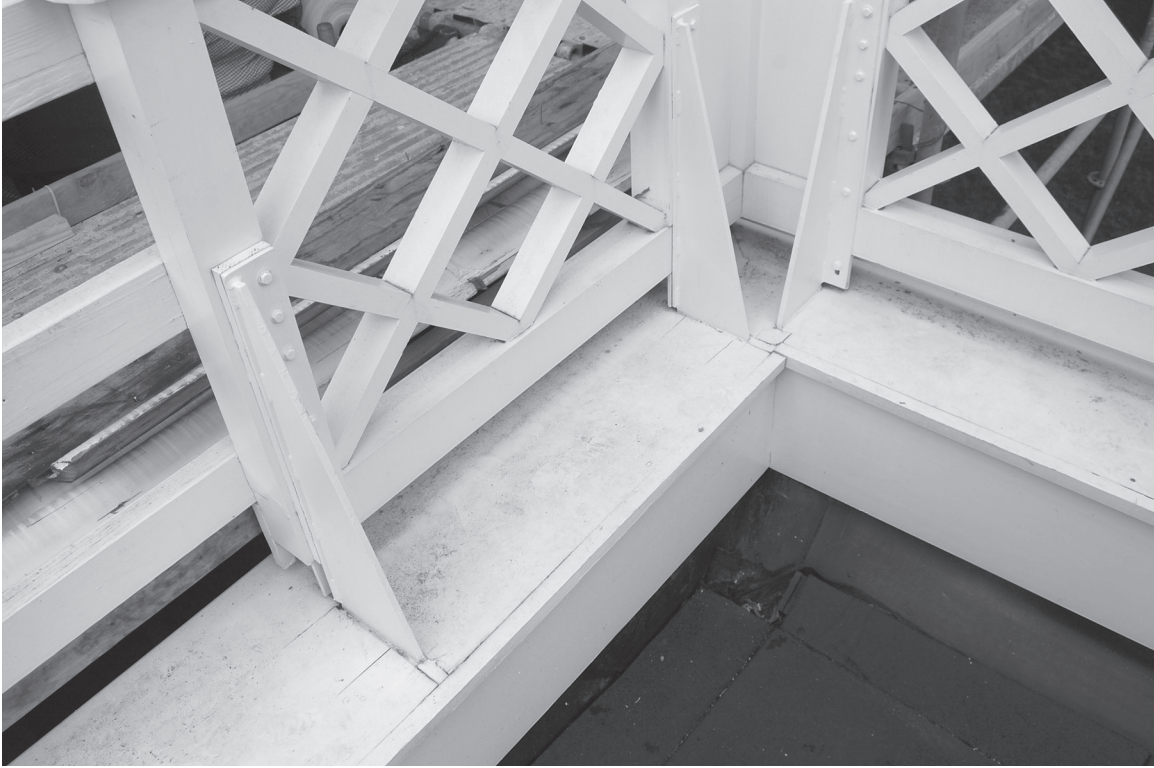
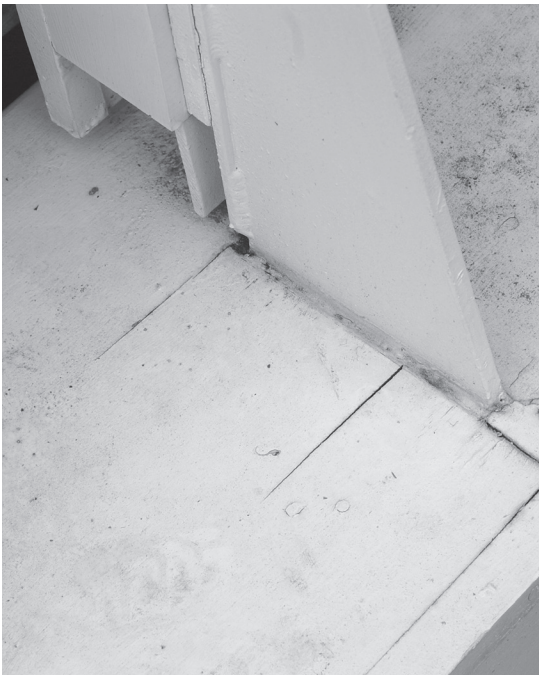
Northeast corner of the colonnade railing. The wood curb beneath the railing has insufficient pitch to drain properly. The metal railing support brackets are not flashed and rely solely on the integrity of sealant to prevent water infiltration.
