UNIVERSITY OF VIRGINIA

PAVILION IX

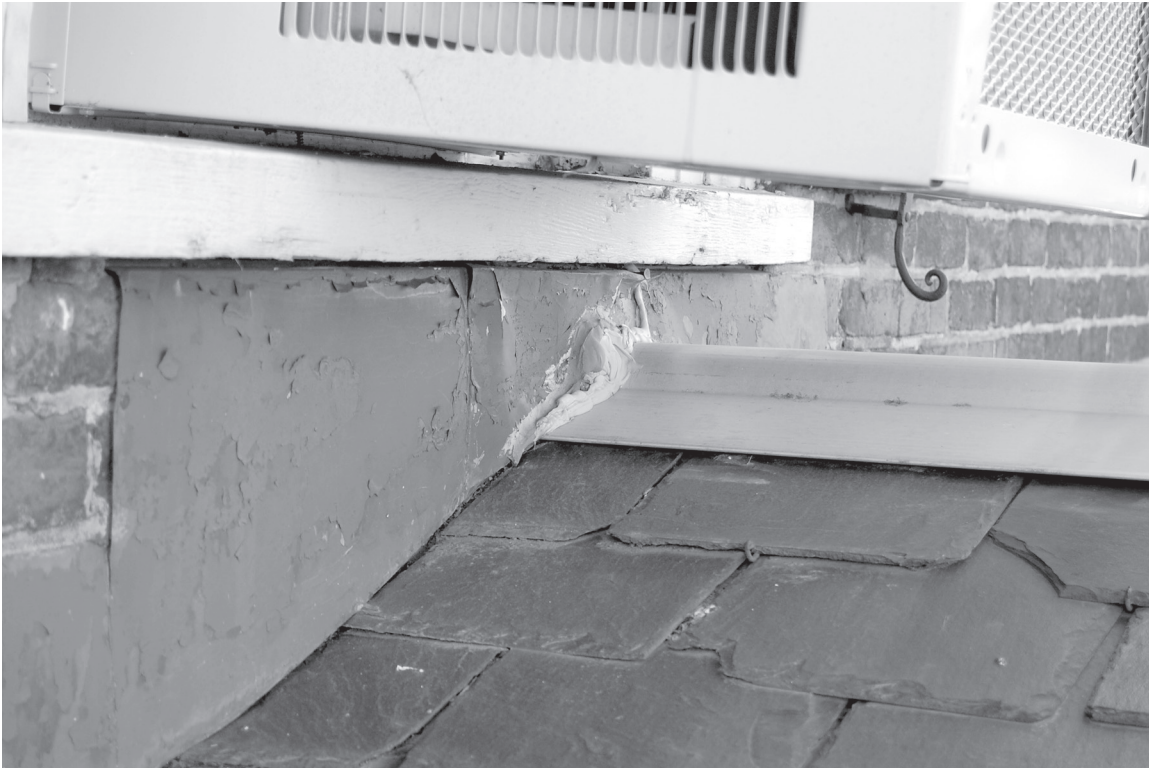
The sheet metal ridge of the roof above the student room at the northeast corner of the pavilion is poorly detailed; sealant has been heavily applied to the joint between the dissimilar metals of the ridge and step flashing. The paint on the painted step flashing is peeling. The roofing slate is chipped and broken.

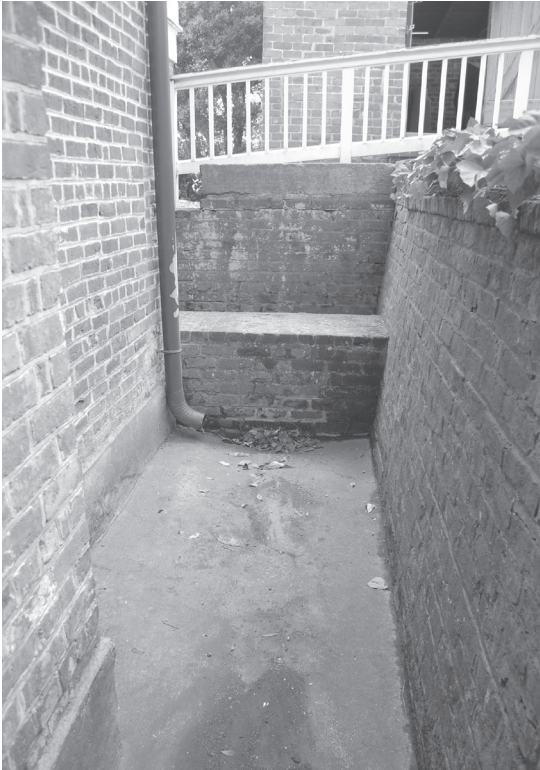
The north areaway is wet and supports the growth of algae, moss, and lichen. The drain grate is corroded and clogged with leaves.

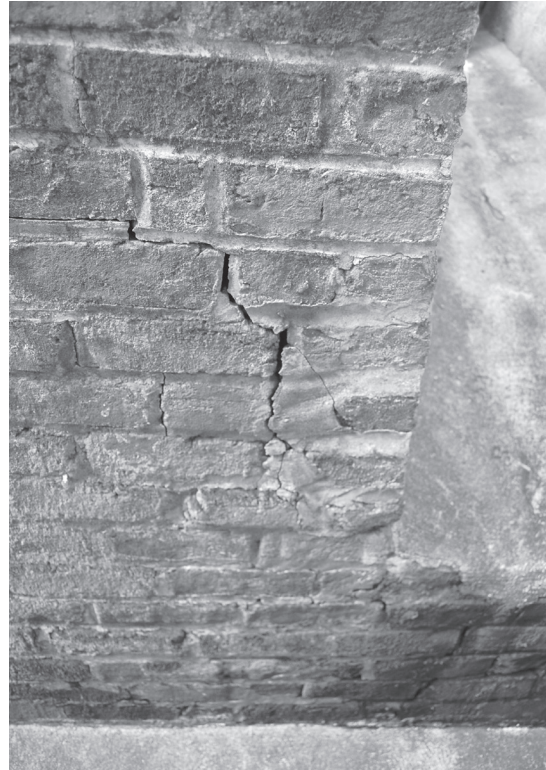
The brick masonry of the retaining wall at the east end of the areaway is cracked and displaced.

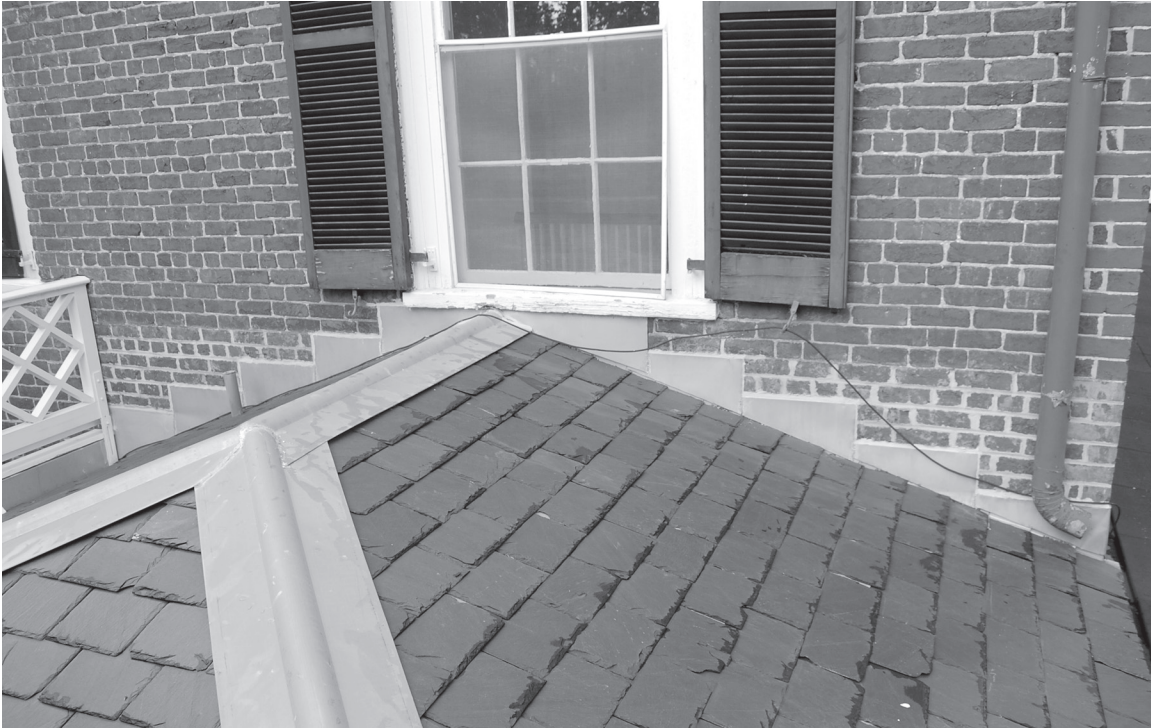
The pointing repairs above the roof of the student room at the southeast corner of the pavilion do not match the color or profile of the original mortar. The brick in this area is discolored where previously applied stucco has been removed. A heavy application of sealant has been applied above the step flashing.

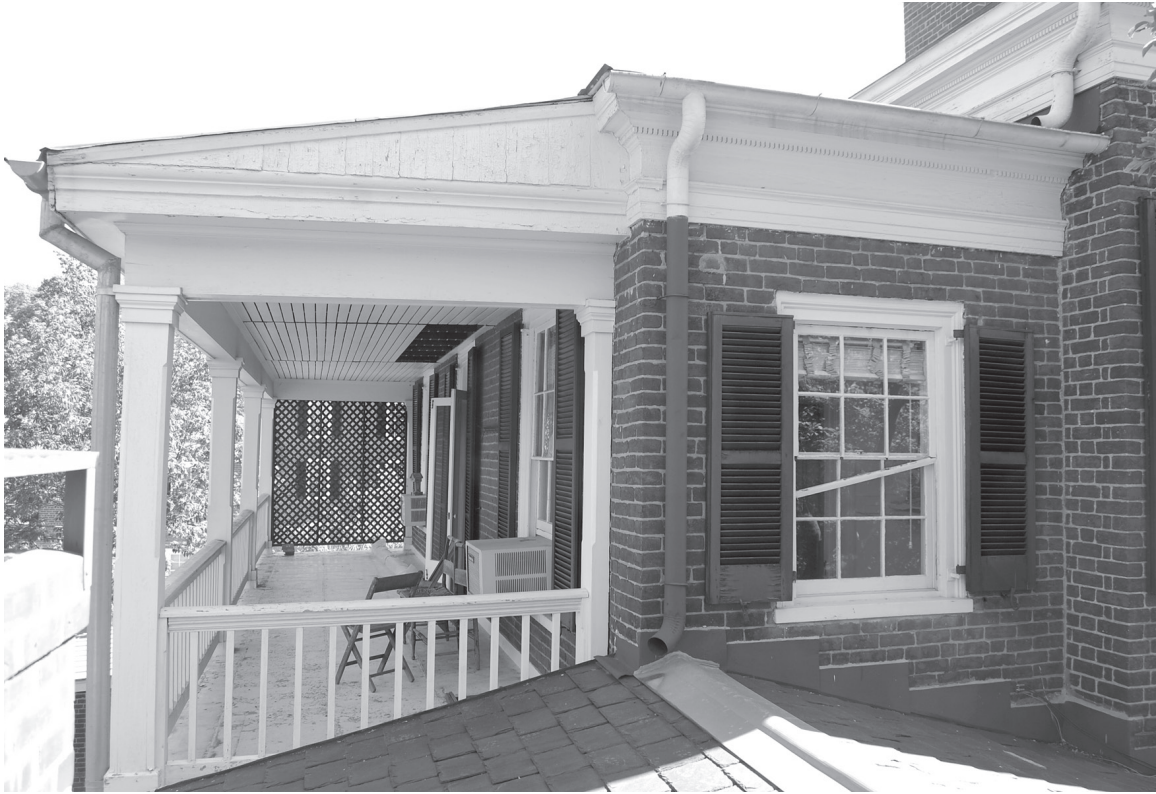
Southwest corner of rear addition. The bottom rail of the upper window sash on the south elevation has failed. A heavy application of sealant has been applied above the step flashing and between the dissimilar metals of the step flashing and ridge. Brick replacement and pointing repairs have not been carefully executed.

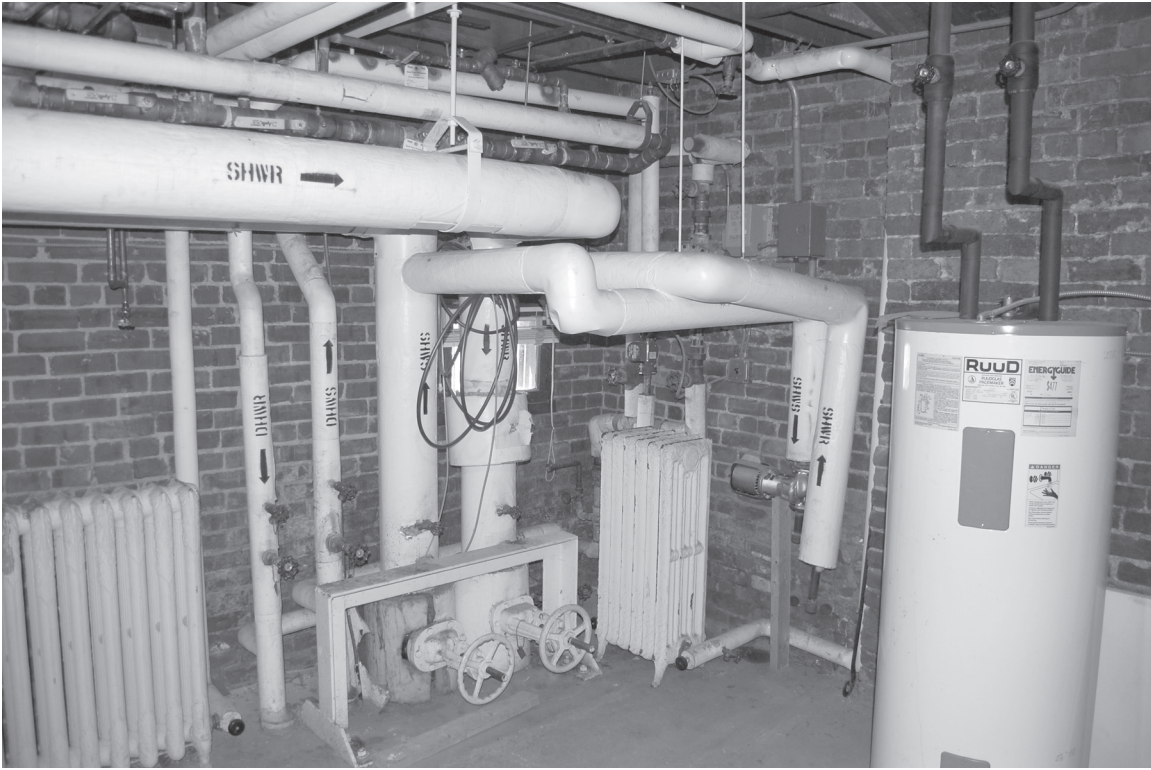
The piping for the central grounds heating system enters the basement of the southwest addition (Room B11) and is routed to the crawlspace north of Pavilion IX. The piping restricts ceiling heights and impedes the use of basement rooms. Room B11 is excessively hot and dry during the heating season.

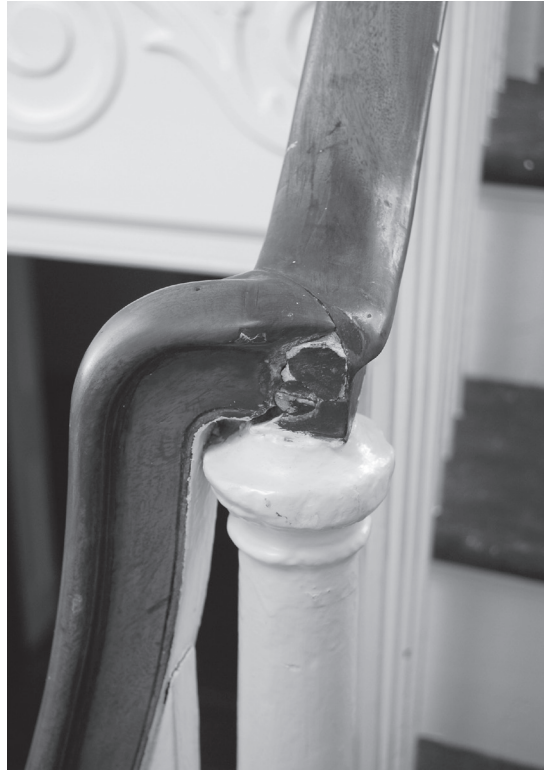
The mitered joints of the handrail on the stairway have been poorly repaired and infused with fillers.
